AMERISPEC[®] INSPECTION SERVICES

Doc #:	82123 Church Building	Inspector:	Todd Newman
Date:	8/20/2023		
Dwelling Address:	433 S 5th Street Church Building Louisville KY 40202		
Client Name:	Archdiocese of Louisville		
Client's Agent:		Real Estate Company:

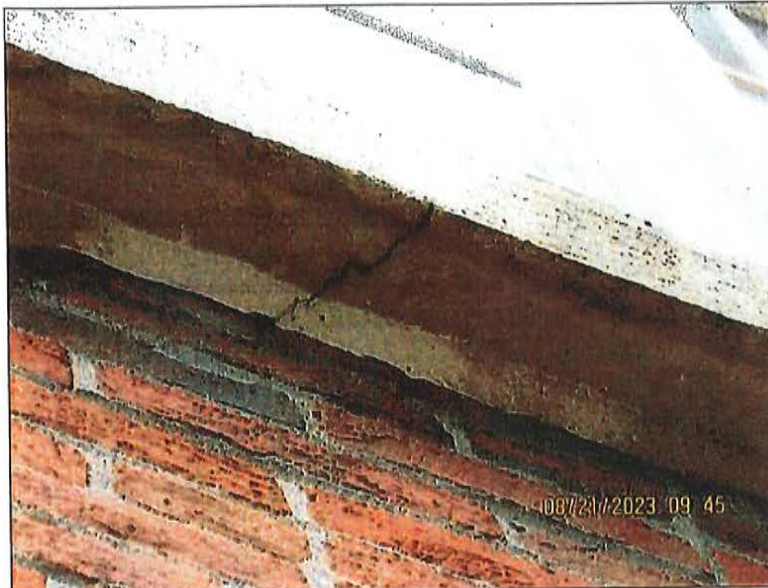
1.0 Item 7(Picture) Building Right

(3) Evidence of prior repairs observed at various locations. We are unable to verify the effectiveness of these repairs although there didn't appear to be further issue.

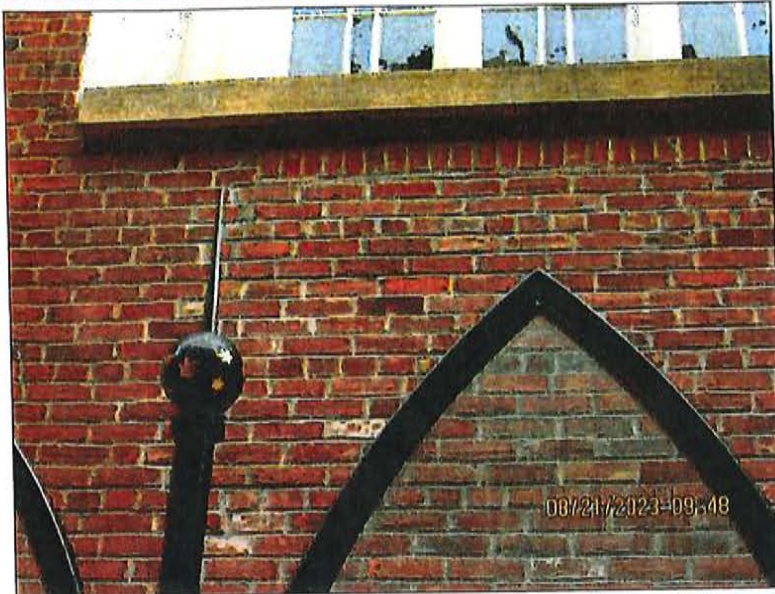
1.0 Item 10(Picture)

(4) Cracked brick and mortar joints observed at left side and left side roof area near door. We recommend professionally repairing the affected area to reduce the potential for water infiltration into the home and further displacement.

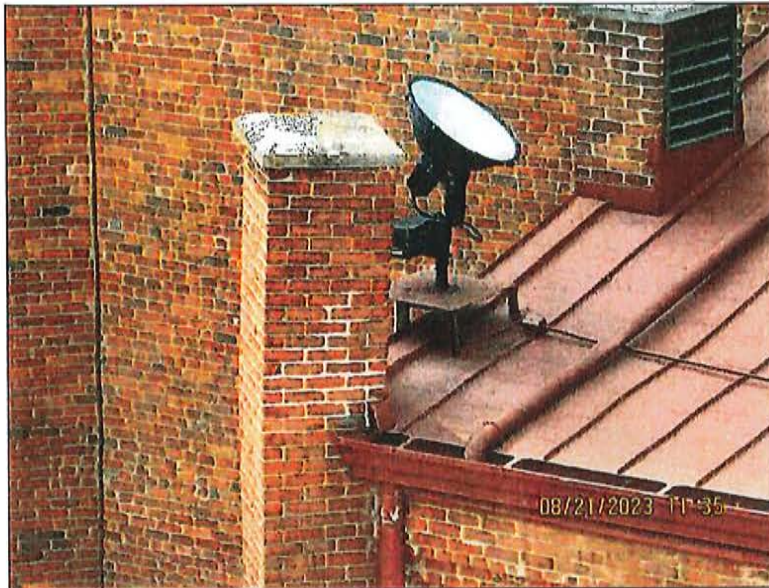
1.0 Item 15(Picture)

(2) Deterioration observed at front of building. It is possible these may be prior repairs where the concrete is not matching and showing signs of failure. Suggest repairs/replacement as needed.

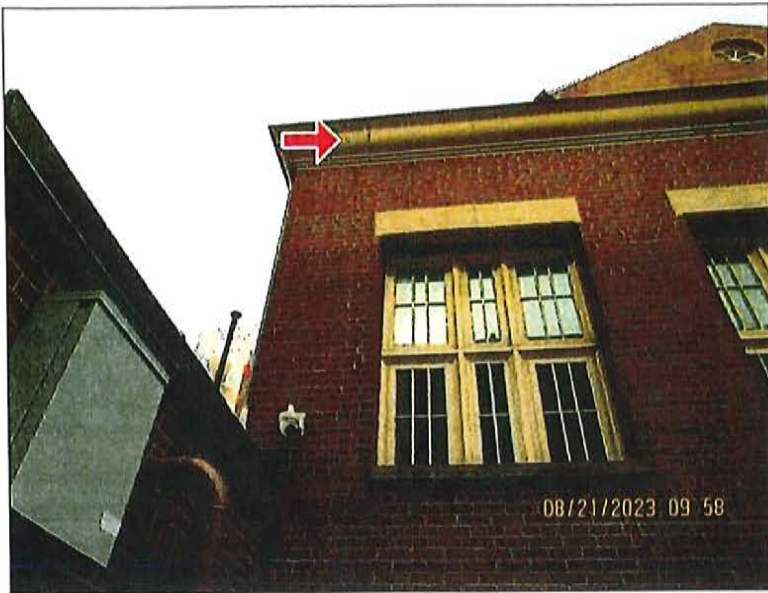
1.1 Item 6(Picture)

(5) Damaged, cracking trim observed at left side steeple. Recommend review by a qualified professional for repair or replacement as necessary.

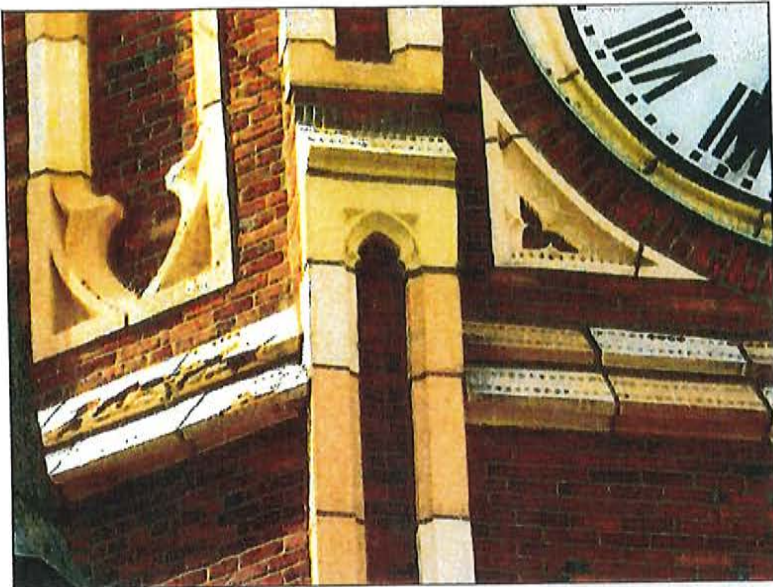
1.1 Item 14(Picture)

(1) Peeling paint observed; suggest scraping and painting as necessary as part of normal maintenance.

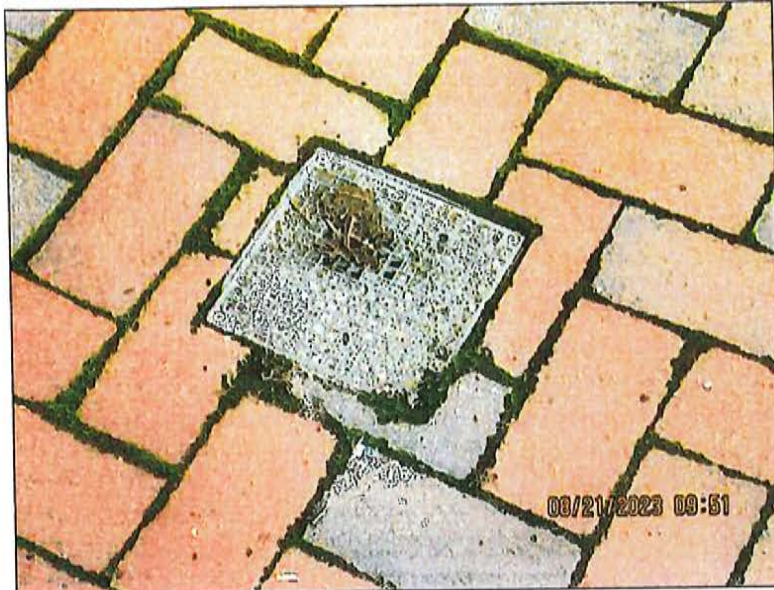
1.10 Item 3(Picture)

(3) Blocked drainage observed at right side of building. Recommend review, cleaning as needed.

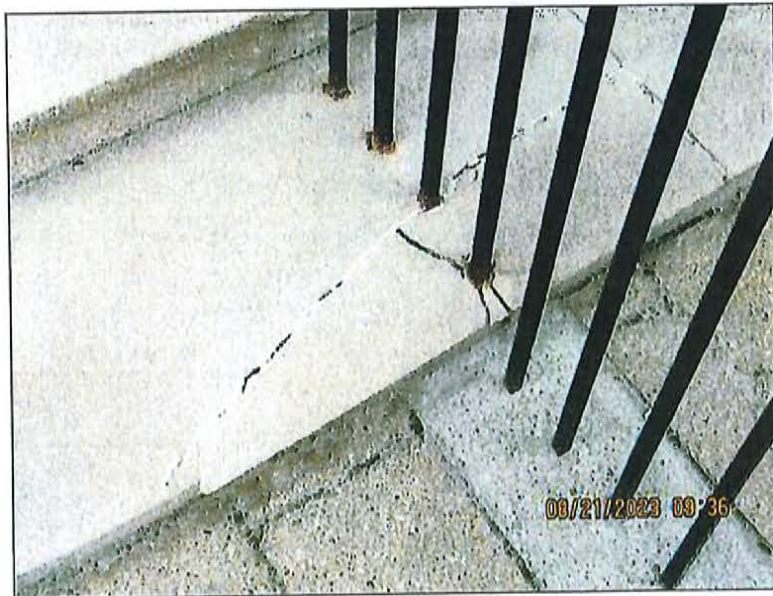
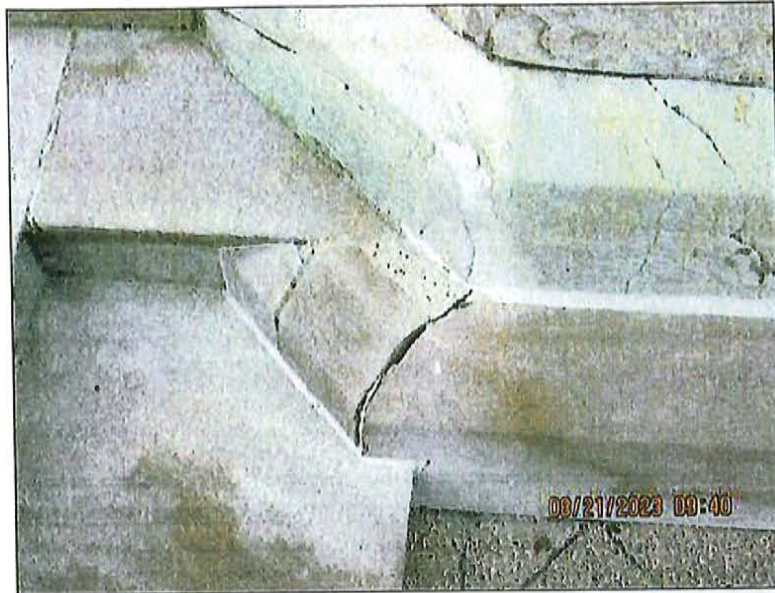
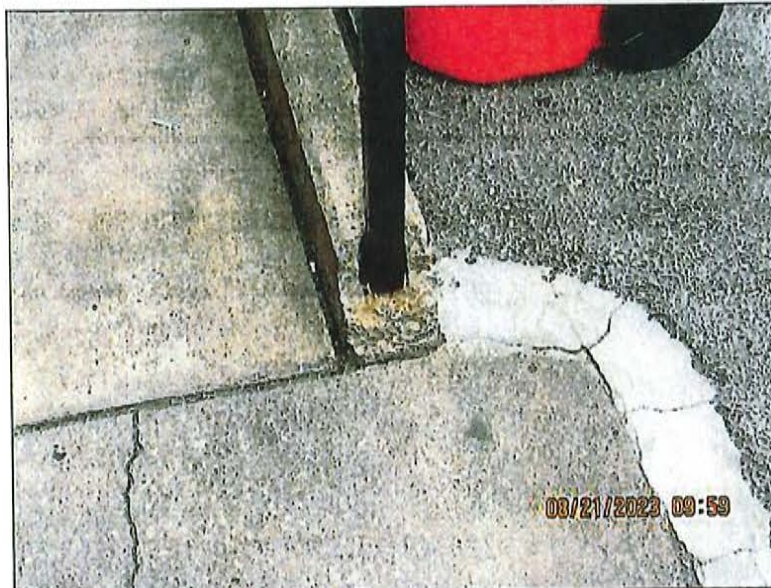
(1) Cracks/deterioration, missing mortar/grout observed at various locations of steps in front of the building, recommend licensed contractor review for repairs as needed.

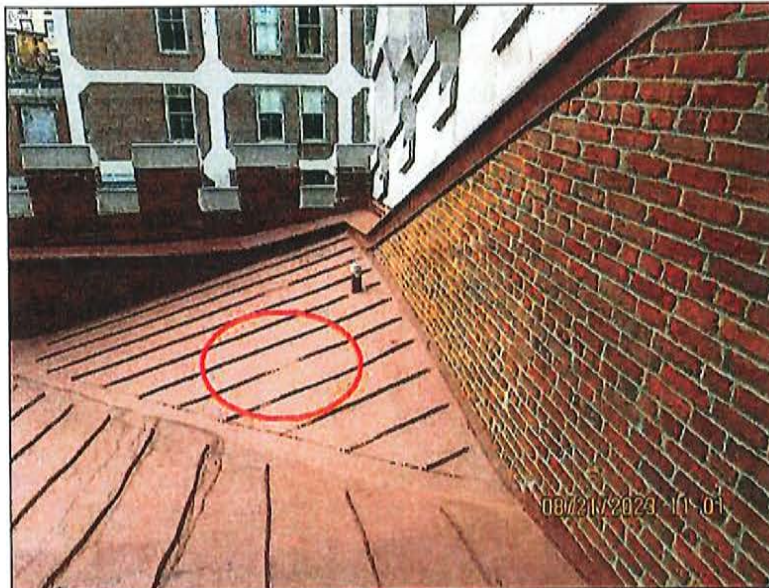
2.0 Item 1(Picture)

Damaged ridges observed at various locations around the roof where possibly people have walked on them. Recommend review by a licensed roofer for repairs as needed.

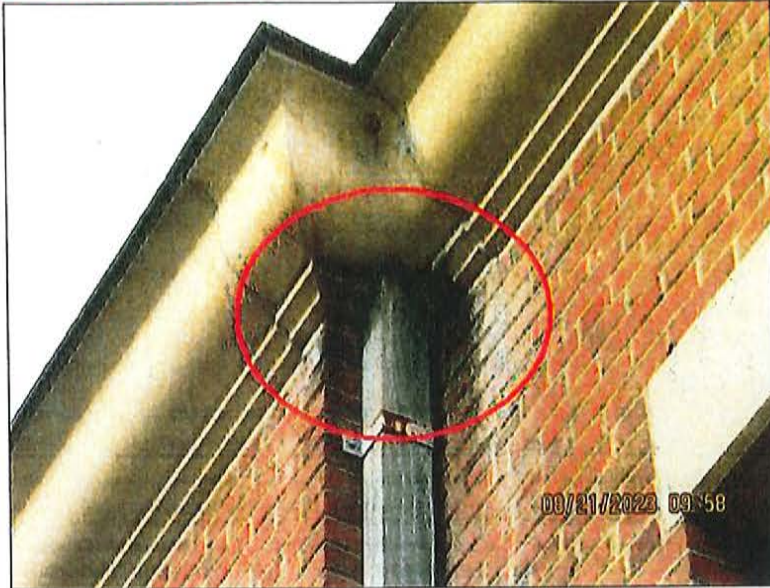
2.2 Item 1(Picture)

(1) Staining observed from possible water leakage at left side of building. Recommend review and repairs as needed by a qualified contractor.

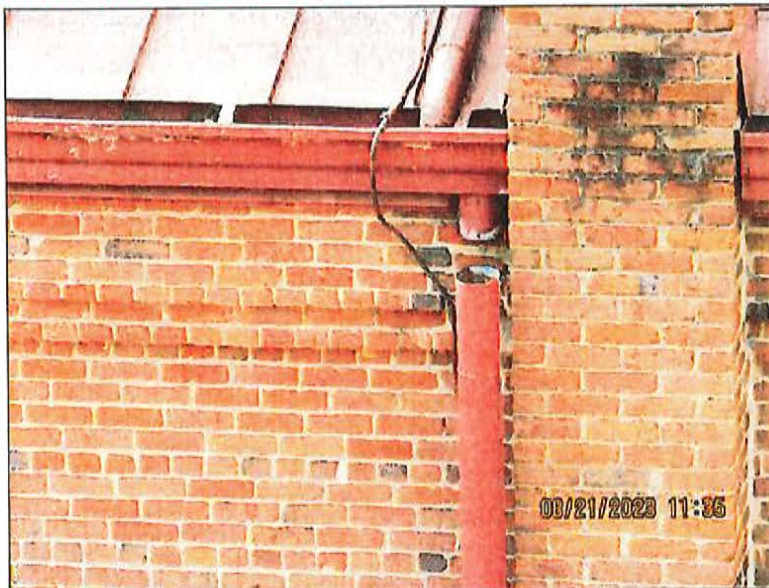
2.2 Item 2(Picture)

(2) Damage observed at left side. Recommend review for repair or replacement as necessary.

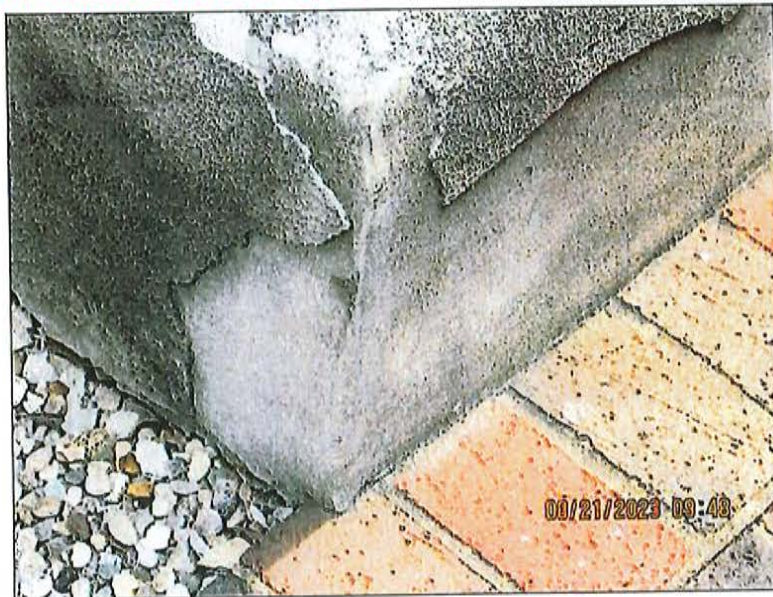
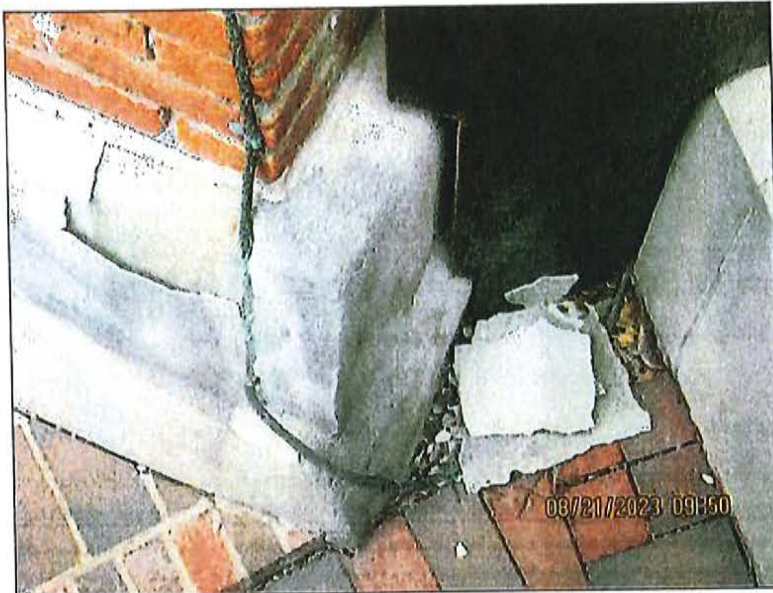
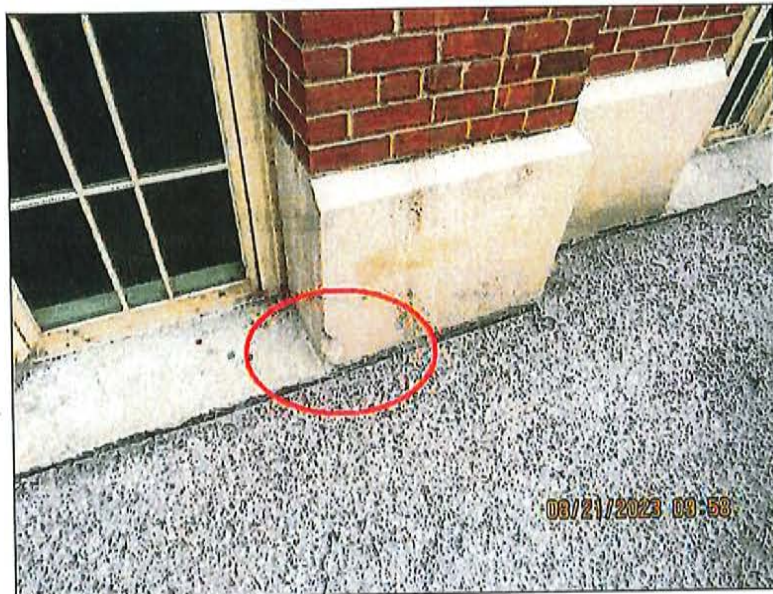
(1) Cement parging is flaking/deteriorated at various locations. Recommend review for repair as necessary.

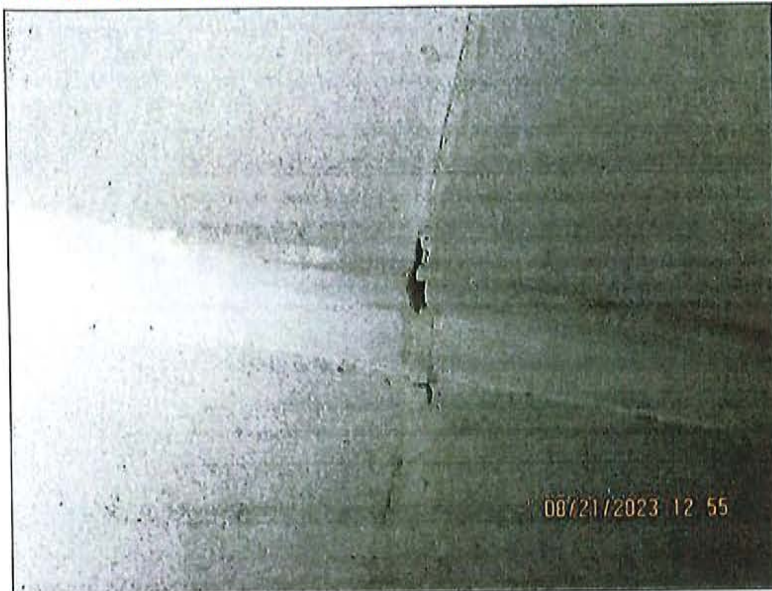
8.0 Item 1(Picture)

Damaged grout observed at right side of alter steps. Recommend repairs as needed by a qualified contractor.

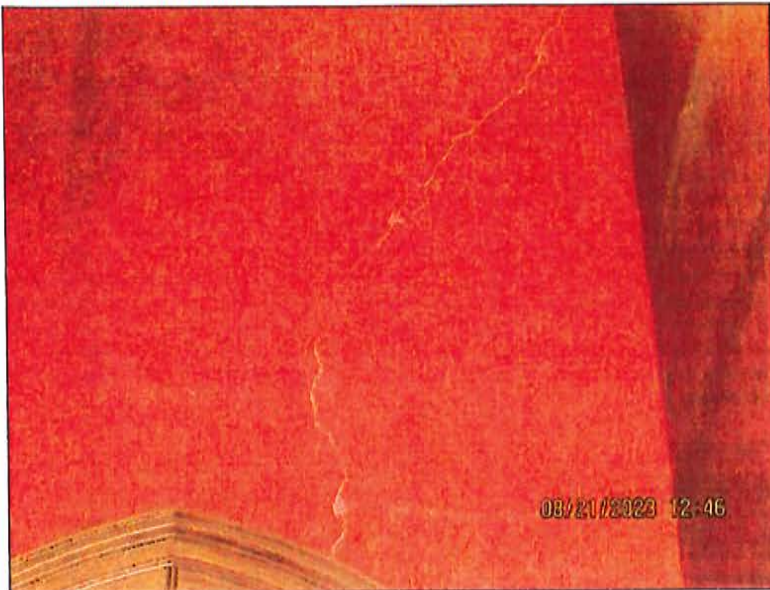
8.1 Item 3(Picture)

(2) Damage, cracking observed at entry way. Recommend repairs as needed by a qualified contractor.

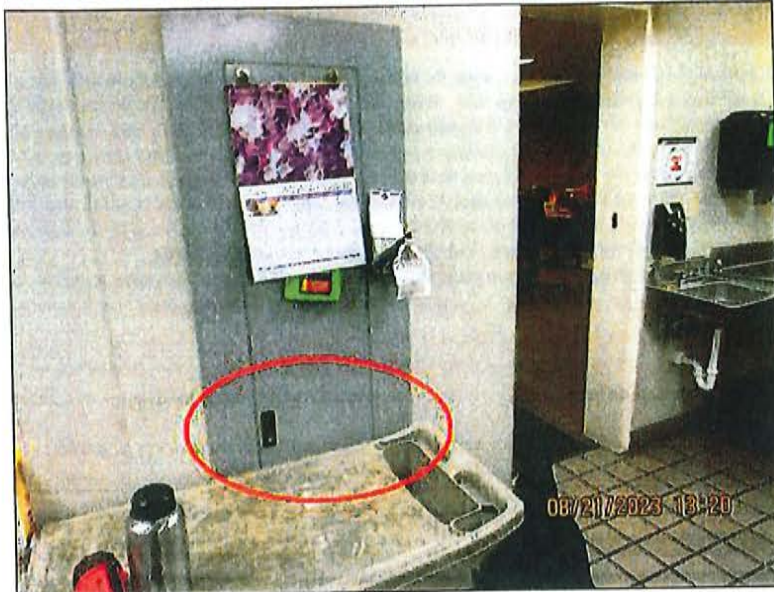
14.3 Item 1(Picture)

Blocked electrical panel observed in kitchen area. This is a potential safety concern. Recommend clearing space.

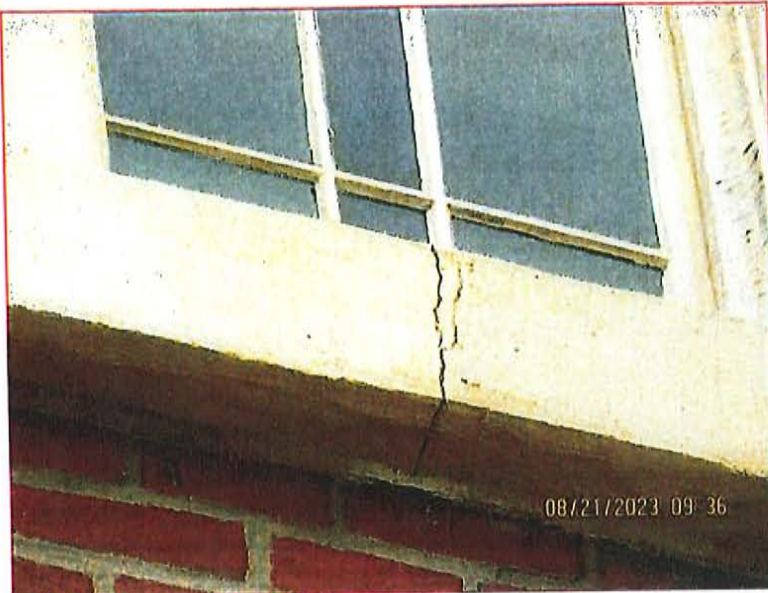
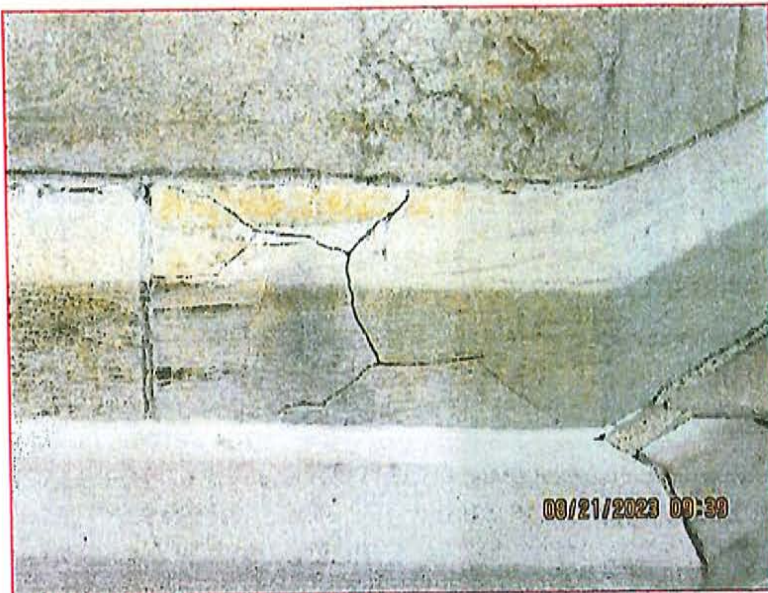
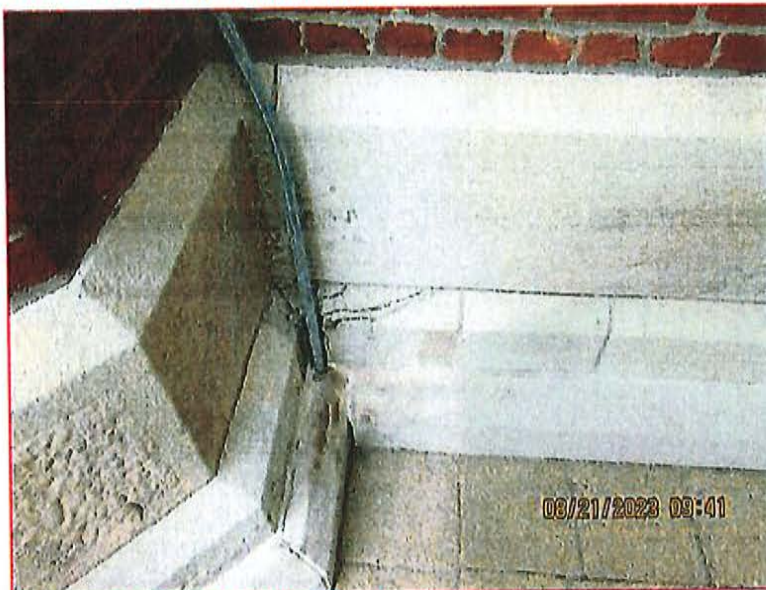
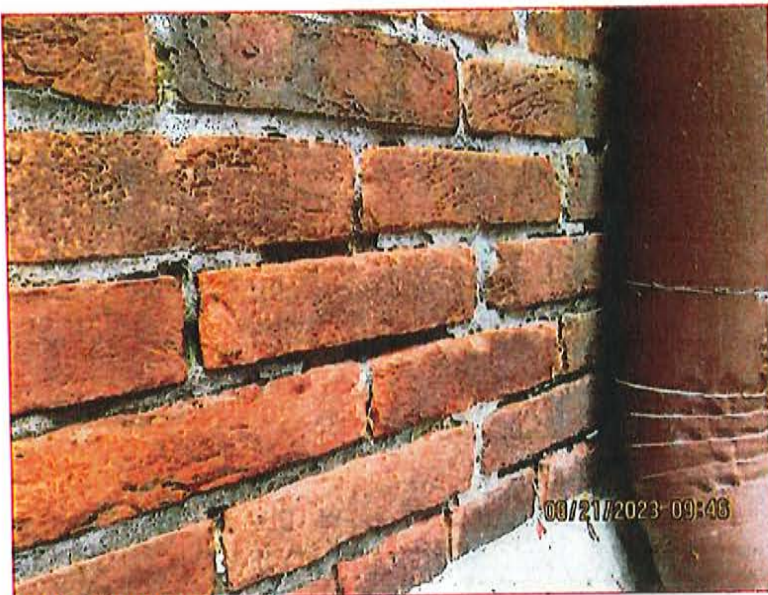
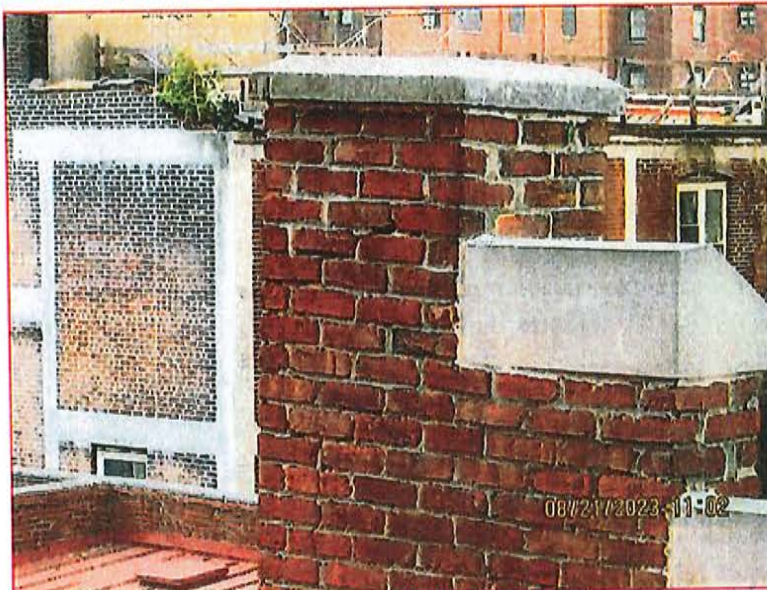
(1) Common cracks observed at various locations, primarily a cosmetic concern. Suggest sealing all concrete joints as well as any cracks in concrete/brick surfaces to prevent water penetration as a routine maintenance effort.

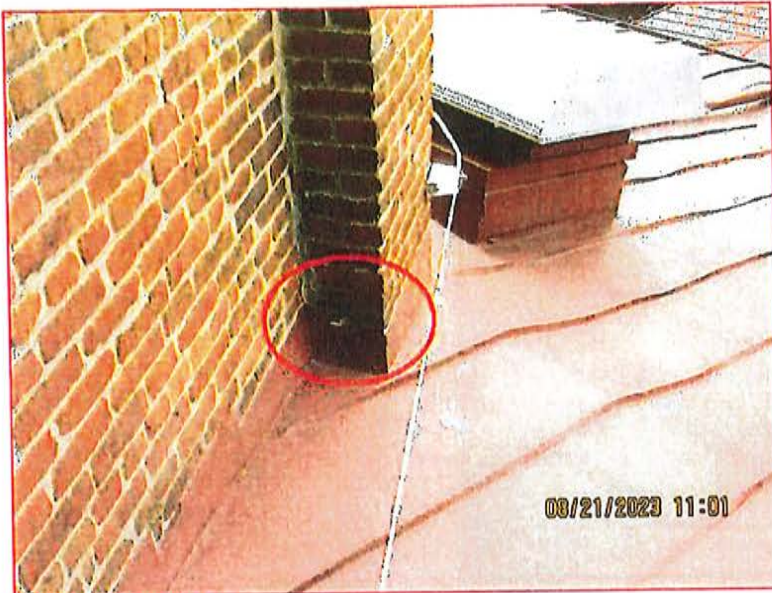
1.0 Item 12(Picture)

(3) Evidence of prior repairs observed at various locations. We are unable to verify the effectiveness of these repairs although there didn't appear to be further issue.

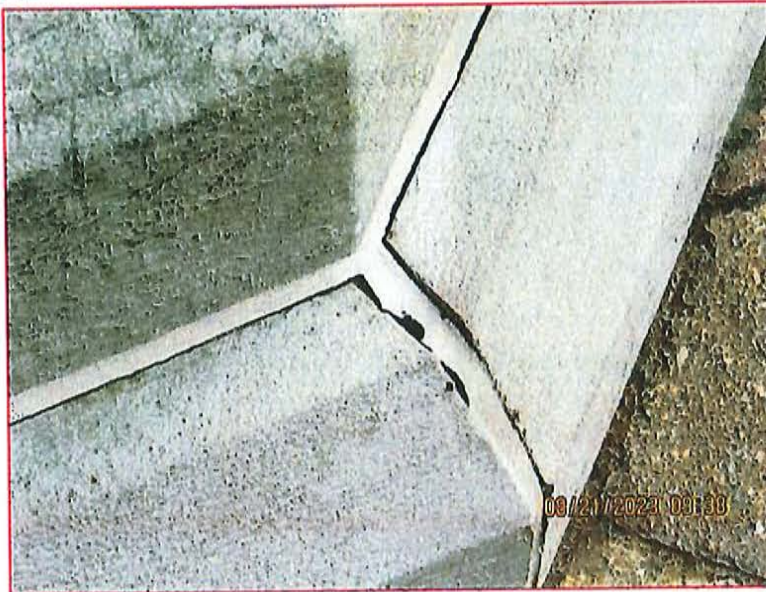
1.1 Item 1(Picture)

(1) Caulking should be applied around all windows, doors, and any voids where necessary.

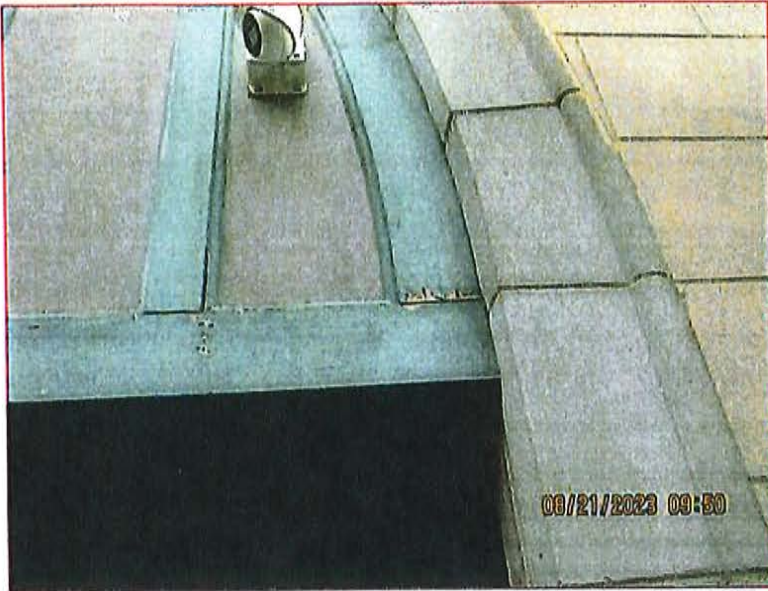
1.1 Item 4(Picture)

(2) Deterioration observed at front of building. It is possible these may be prior repairs where the concrete is not matching and showing signs of failure. Suggest repairs/replacement as needed.

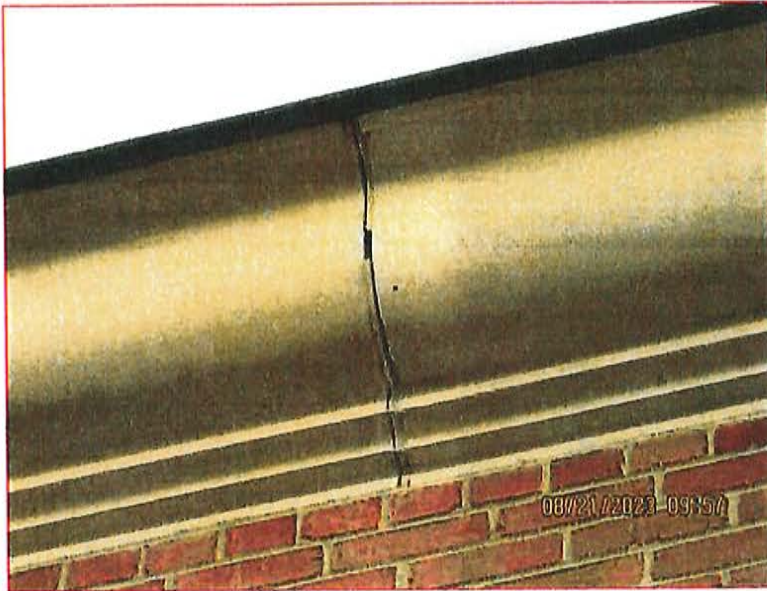
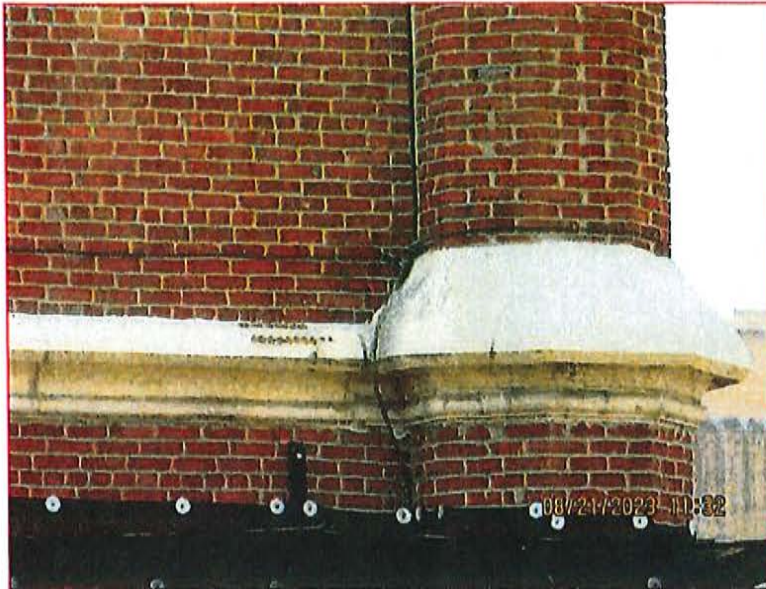
(4) Missing grout/mortar observed at rear of building; suggest replacement as needed.

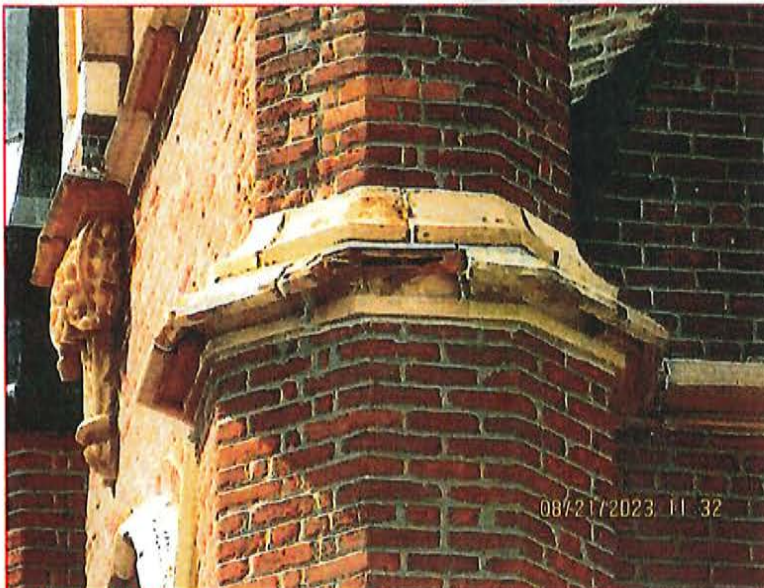
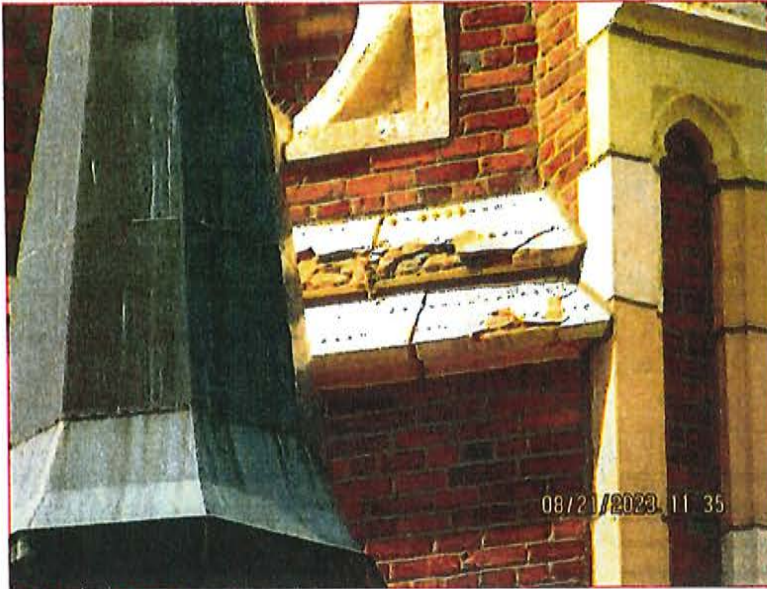
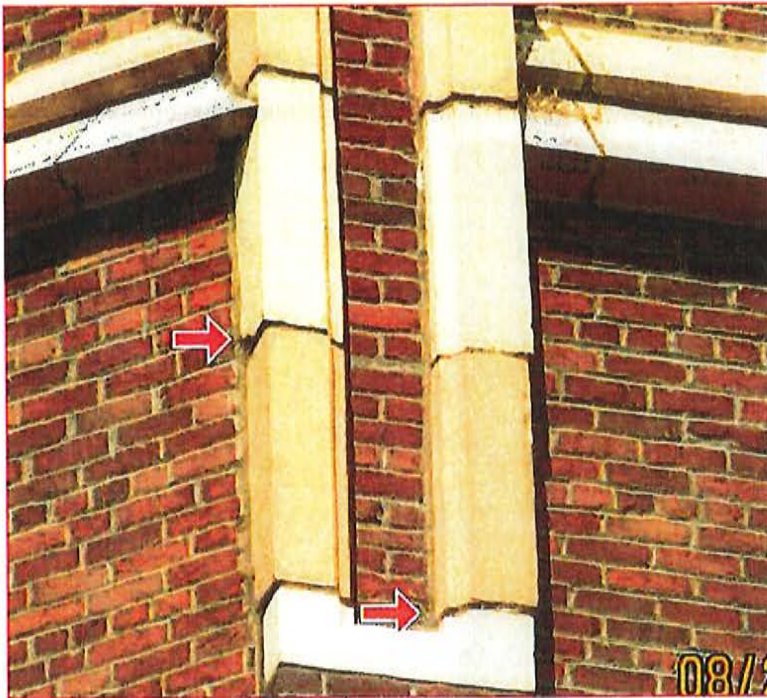
(6) Damaged/deteriorated trim, missing mortar/grout observed at various locations around steeple area. Recommend review of steeple and repairs as needed as these tiles may be a fall hazard. Recommend repairs to prevent further damage.

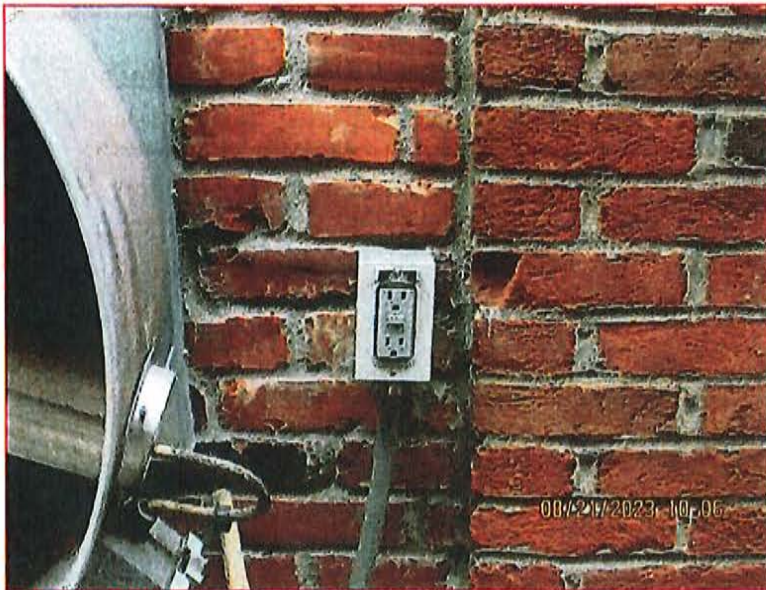
1.5 Item 1(Picture)

(1) The outside receptacle cover at right rear of building is damaged and needs repair or replacement.

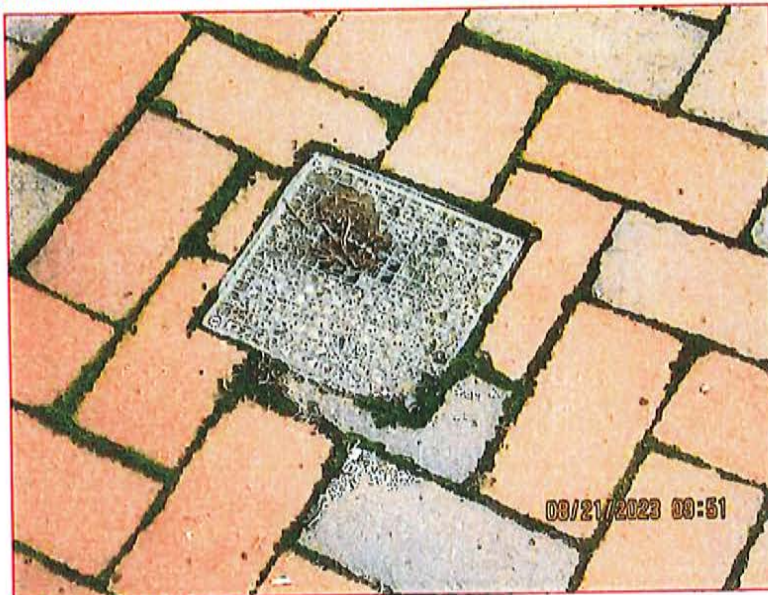
1.10 Item 3(Picture)

(3) Blocked drainage observed at right side of building. Recommend review, cleaning as needed.

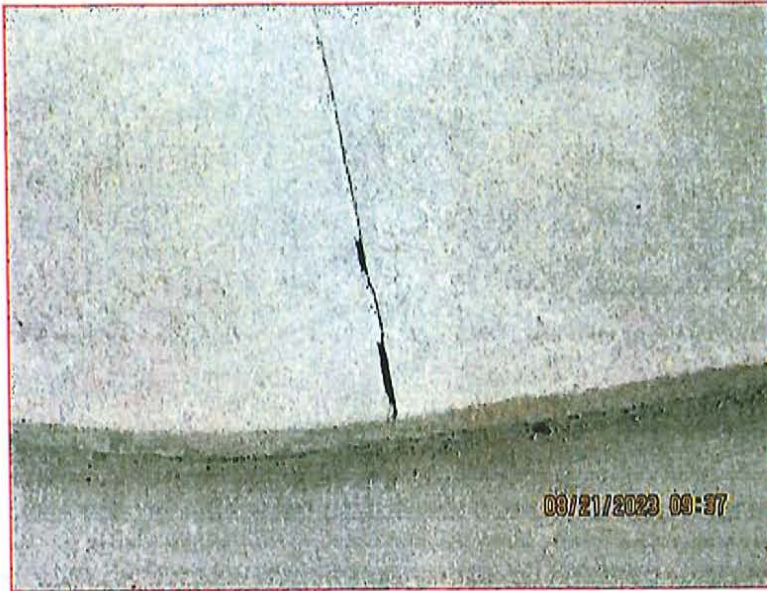
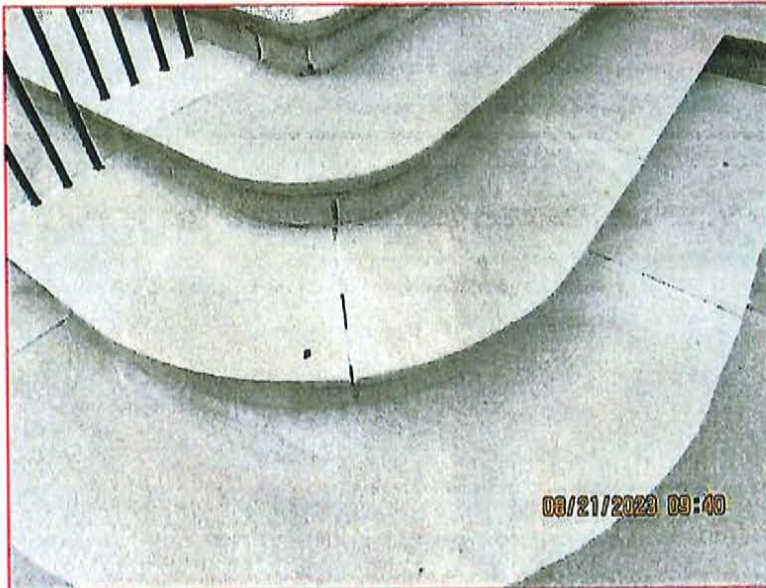
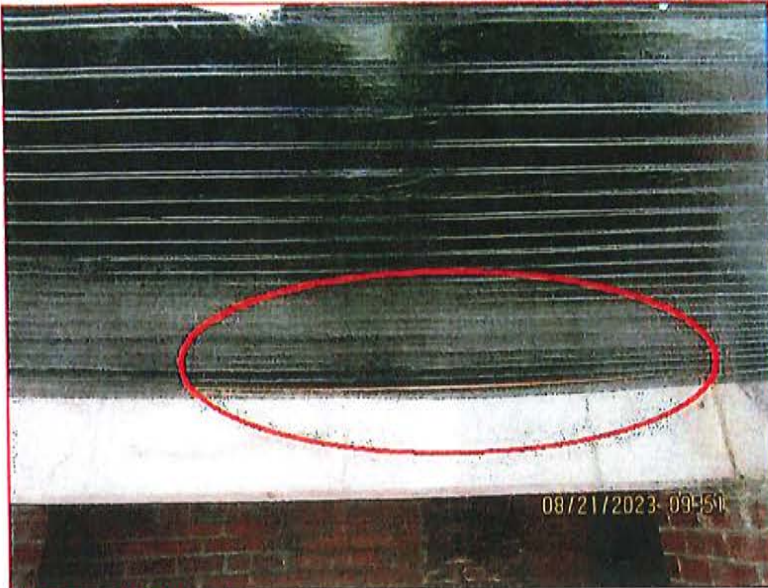
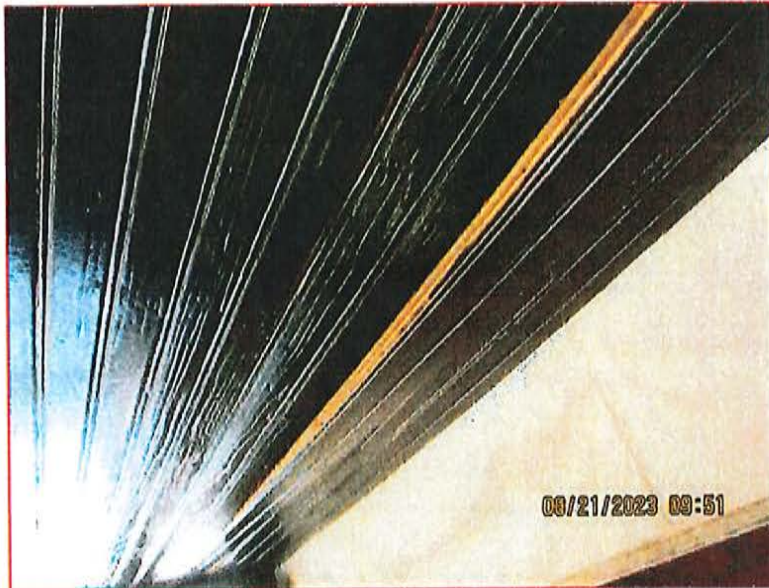
(1) Cracks/deterioration, missing mortar/grout observed at various locations of steps in front of the building, recommend licensed contractor review for repairs as needed.

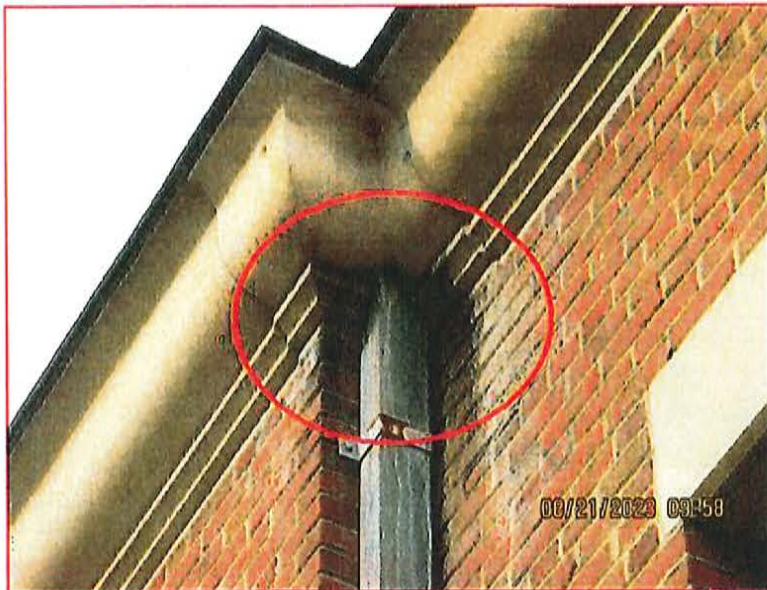
2.2 Item 1(Picture)

(1) Staining observed from possible water leakage at left side of building. Recommend review and repairs as needed by a qualified contractor.

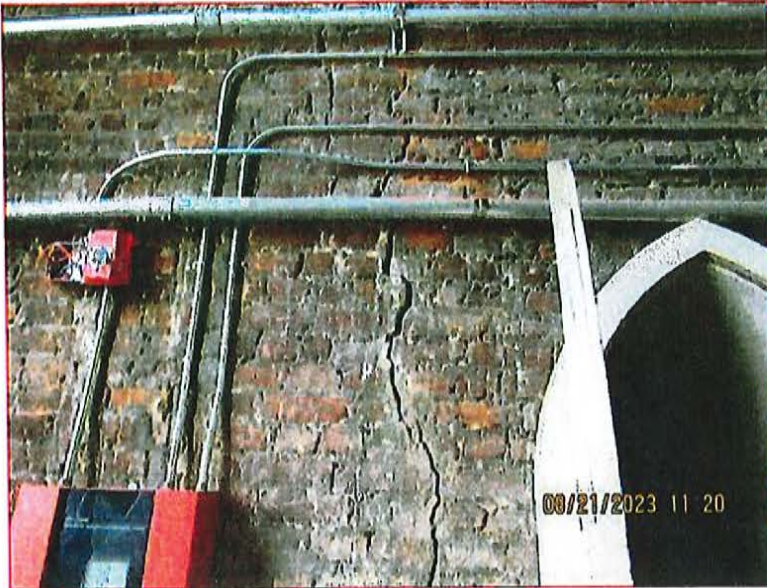
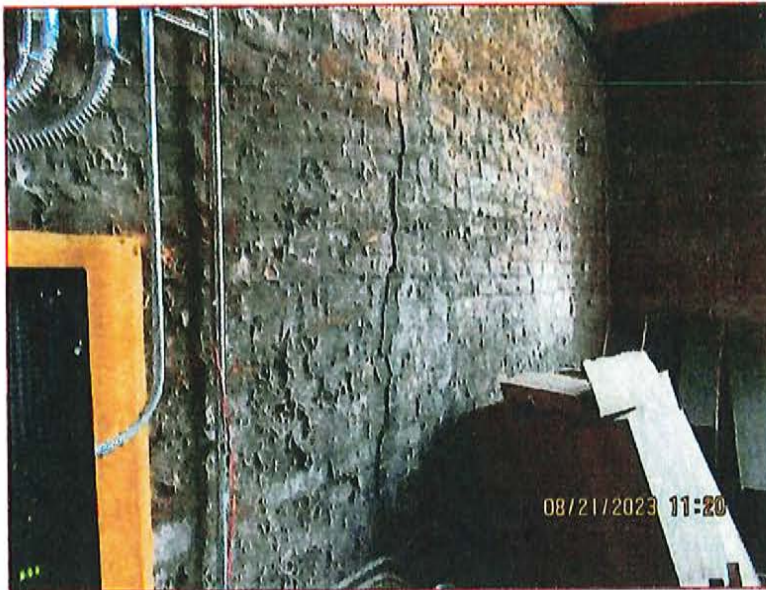
(2) Damaged, deterioration observed at right side of building, recommend repairs as needed by a qualified contractor..

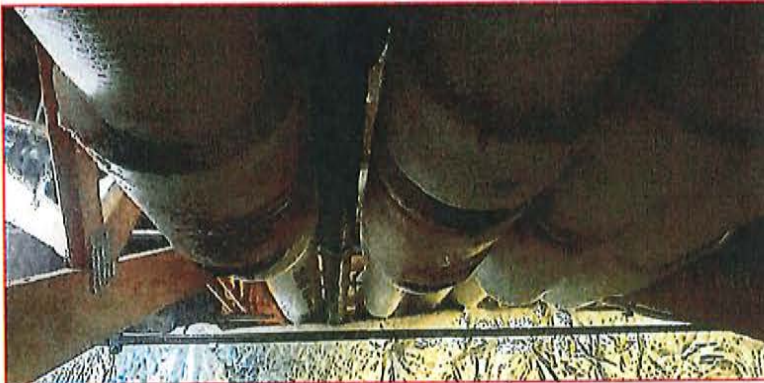
13.0 Item 1(Picture)

Supply plumbing was leaking at the time of the inspection at two different areas. These would be for water from the chiller and supply. Recommend review by a licensed plumber for repair or replacement, as necessary.
