AMERISPEC[®] INSPECTION SERVICES

Doc #:	82123 Church Building	Inspector:	Todd Newman
Date:	8/20/2023		
Dwelling Address:	433 S 5th Street Church Building Louisville KY 40202		
Client Name:	Archdiocese of Louisville		
Client's Agent:		Real Estate Company:

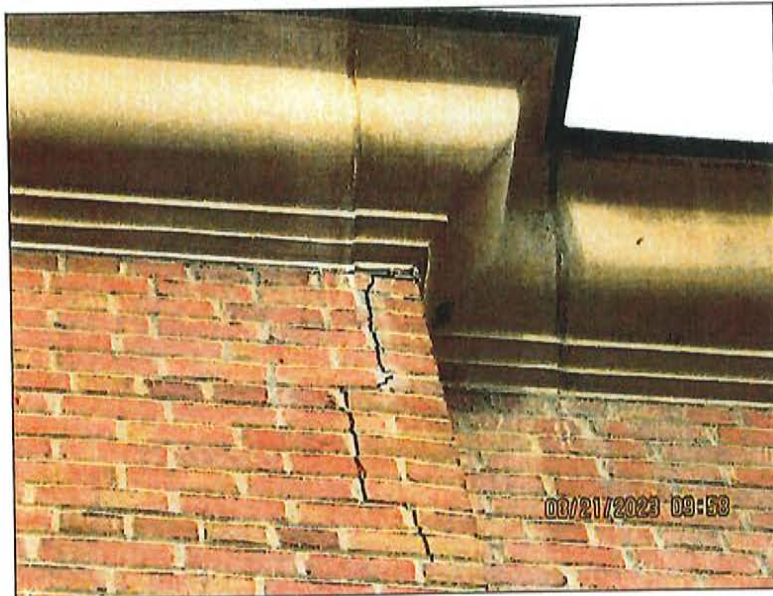
1.0 Item 11(Picture)

(4) Cracked brick and mortar joints observed at left side and left side roof area near door. We recommend professionally repairing the affected area to reduce the potential for water infiltration into the home and further displacement.

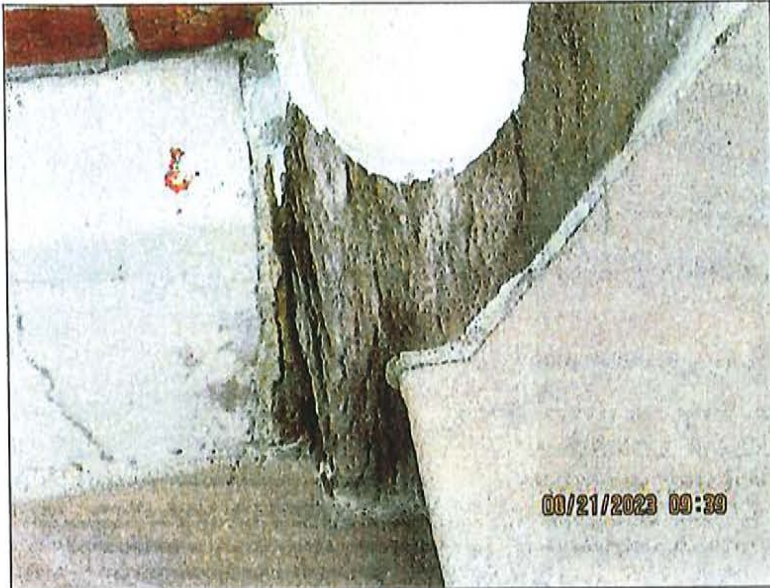
1.1 Item 2(Picture)

(2) Deterioration observed at front of building. It is possible these may be prior repairs where the concrete is not matching and showing signs of failure. Suggest repairs/replacement as needed.

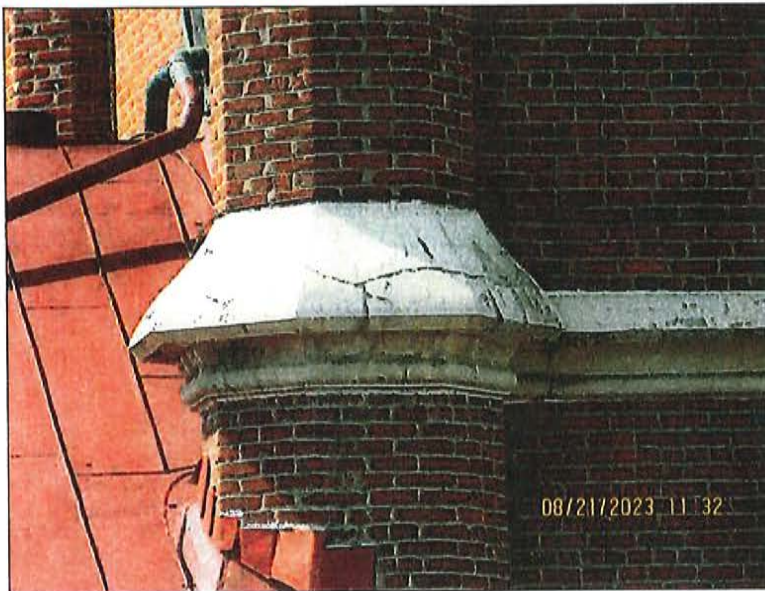
1.1 Item 7(Picture)

(5) Damaged, cracking trim observed at left side steeple. Recommend review by a qualified professional for repair or replacement as necessary.

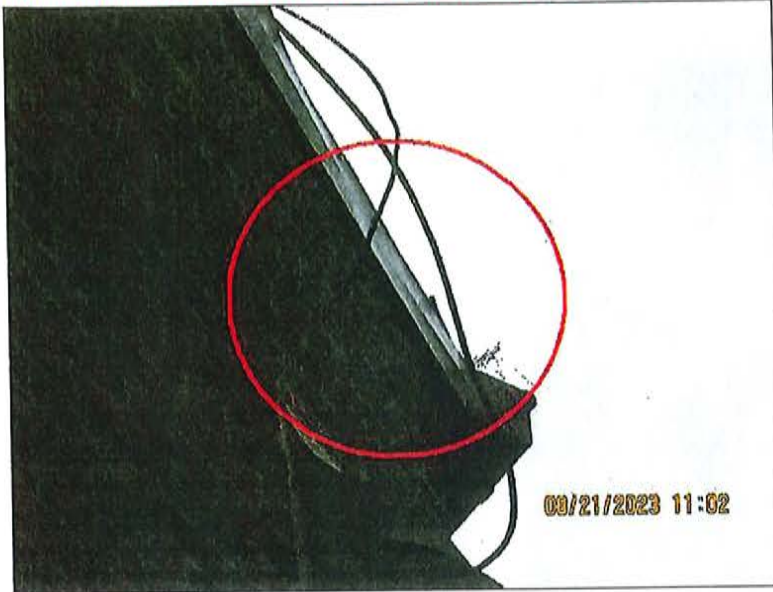
1.5 Item 2(Picture)

(2) Frayed grounding wire observed at right roof, near door. This may no longer be in use, although that could not be confirmed. Recommend review and repairs as needed by a licensed electrician if client wishes further evaluation.
